Technical expertise on the cause of engine failure of the Mitsubishi Pajero Sport

Ján Mandelík¹

ABSTRACT: *The article concerns the case of the damage to the Mitsubishi Pajero Sport engine and the methodology a technical expert applied to identify a direct cause of failure. The engine failure occurred while a vehicle was being repaired to eliminate air conditioning malfunction and engine overheating. When repairing, it was necessary to replace a cylinder head and the pistons were checked removing the pulley from a crank shaft. After the repair had been completed and after 16-day vehicle operation, engine timing belts got damaged. To eliminate this malfunction, damaged belts were replaced. Thirty (30) days after the vehicle had been put into operation, emergency engine failure occurred, and a technical expert was called upon to assess the quality of the repairs having been performed. The article describes the procedures and methodology a technical expert applied. In the conclusion, the findings are stated. To determine the cause, a vehicle was on the car service station premises, where a technical expert was present and according to his instructions, diagnostic and subsequent disa

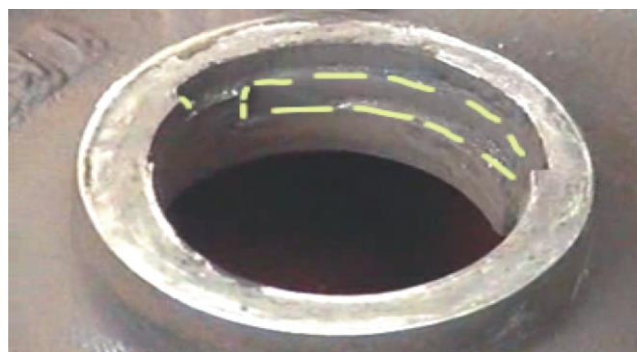
Figure 3: Marked damaged zones on the pulley.

pulley – the internal part of the surface is significantly damaged within the reach of the wedge, traces of excessive turns compared with the position secured by a wedge- Fig.3

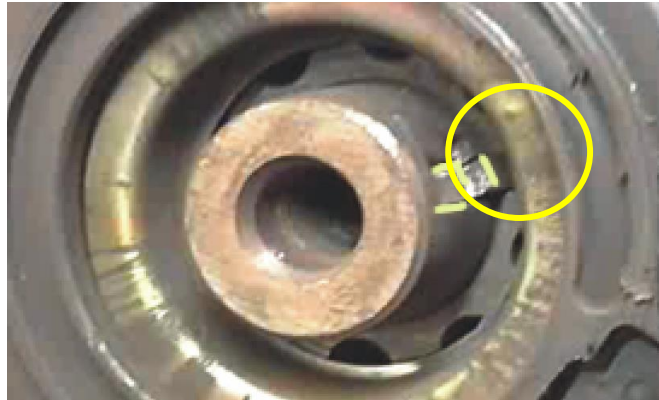
Figure 4: Marked damaged zone on the wedge

wedge – a broken front part in Fig. 4

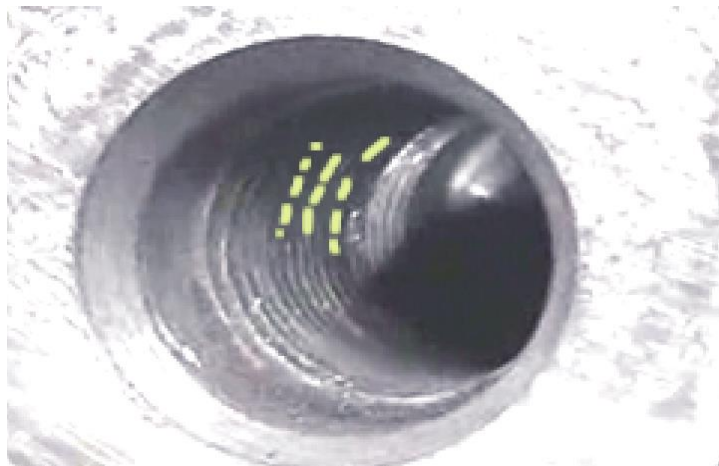
Figure 5: Marks of the damage to the crankshaft

crankshaft – damaged, imprints on the internal thread for the pulley bolt in Fig. 5

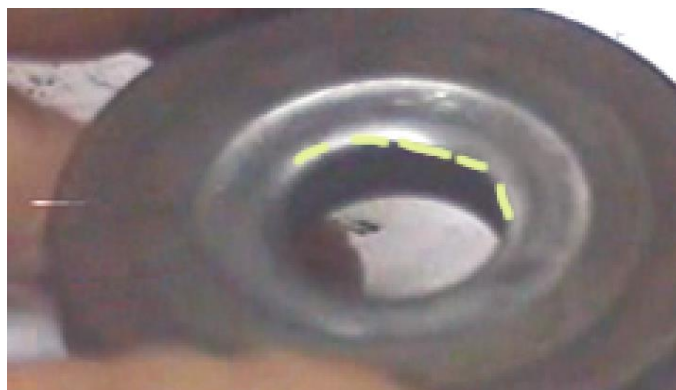
Figure 6: Marked zone of the damaged pulley bolt washer

Pulley bolt washer – significant imprints in the contact area with the bolt in Fig. 6

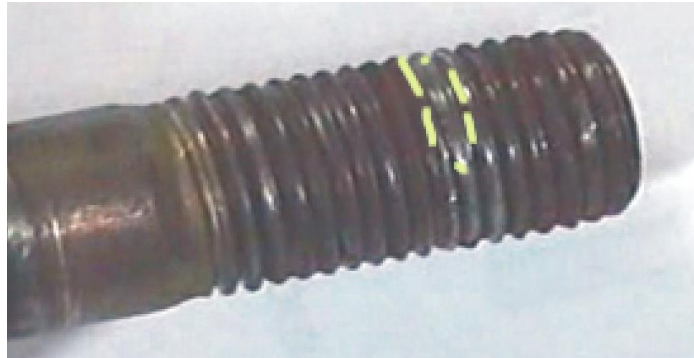
Figure 7: Marked damaged zones of the pulley bolt

Pulley bolt – imprints on the thread at about half of the bolt length, axial clearance detected when fastening into the crankshaft 5 – 8 mm in Fig.7

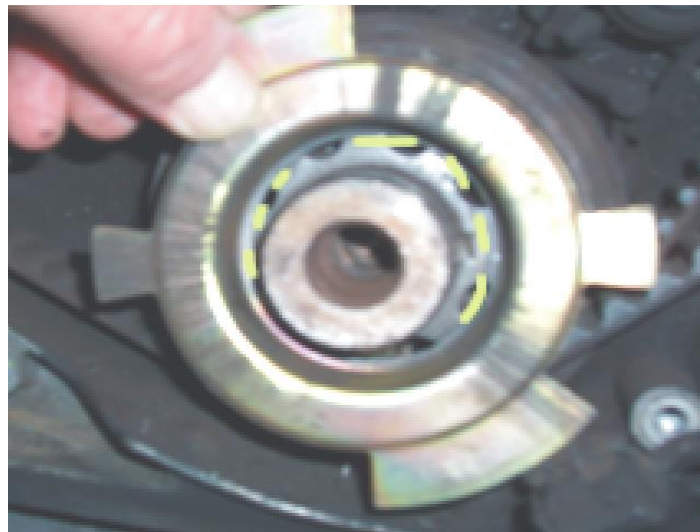
Figure 8: Marked line of the damage to the engine speed sensor disc

Speed sensor disc – imprints inside the opening for the crankshaft, original diameter increased by about 10 mm – shown in Fig. 8

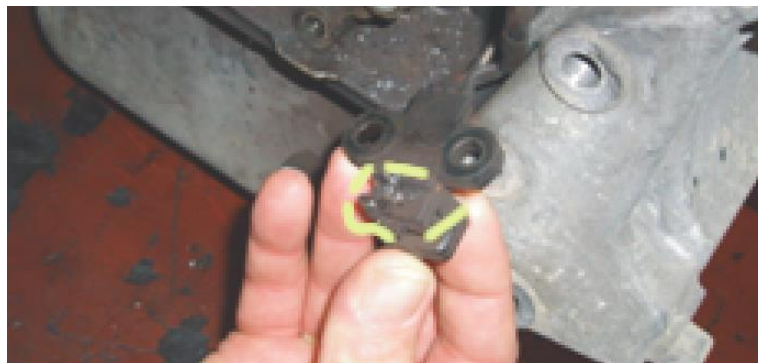
Figure 9: Marked line of the damage to engine speed sensor

Speed sensor – a damaged sensing part – shown in Fig.9
